A Comprehensive Visual Assessment of 69 kV and 115 kV Overhead Transmission Lines

WAKE EMC INSPECTION

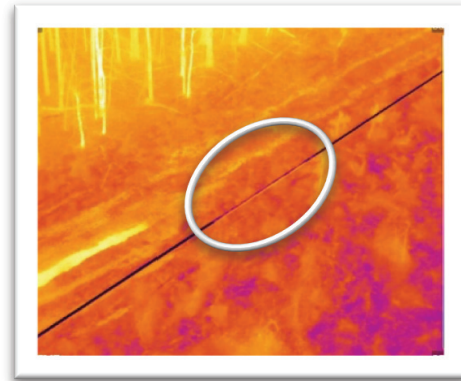
IR image of conductor temperature anomaly

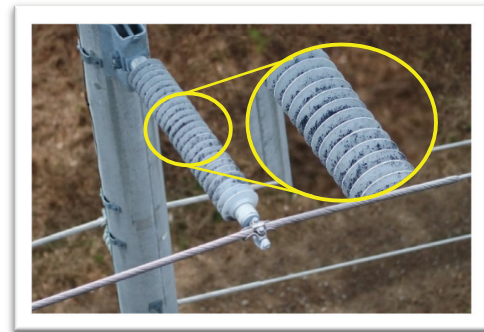
Contaminated insulator

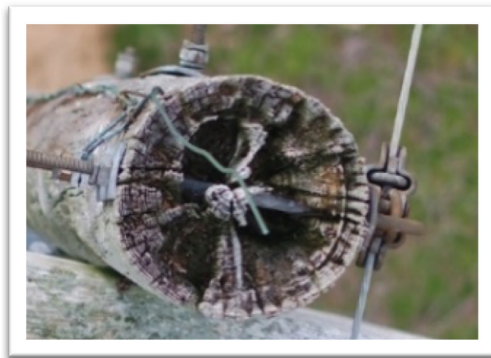
Pole rot with exposed through hardware

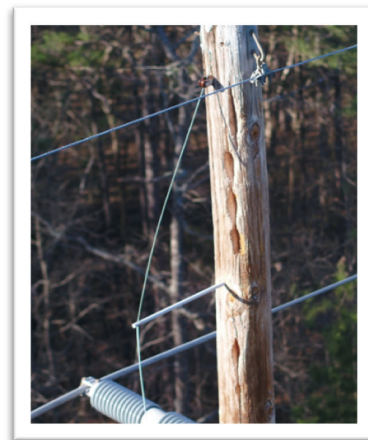
Repeated woodpecker damage
